Performance test HFPD and PryCam Wing sensor

Prysmian Netherlands B.V.

Report no.: 16-1724

Date: 2016-04-08

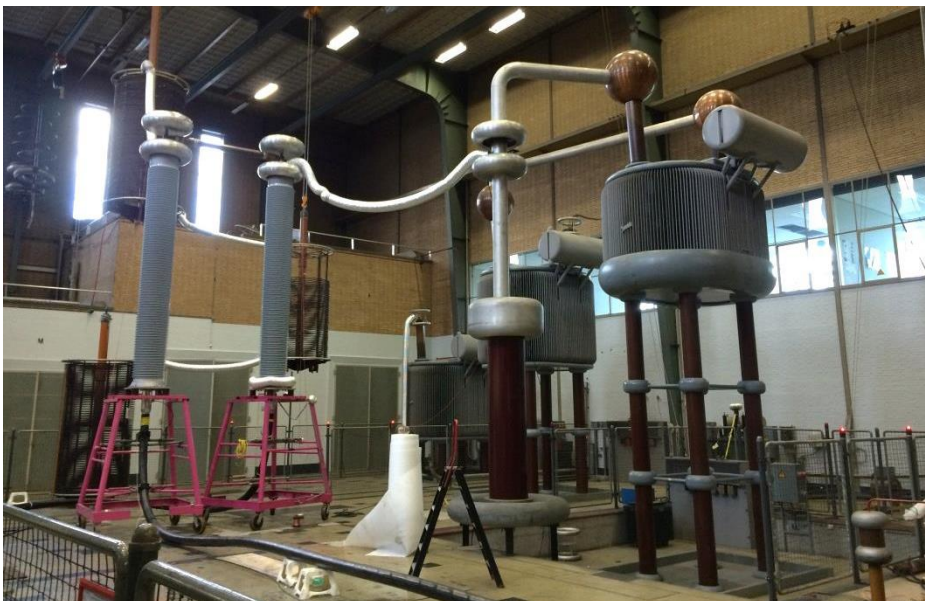
Figure 2 Photo of the test loop.

The tests have been performed on a cable system consisting out of a cable loop of approximately 30 meters with two cross-bonding joints (type CFJX-420) and two outdoor terminations (type OTC-420). The cable is of the voltage class 220/380 kV with a 3000 mm² Milliken type Aluminum conductor. A schematic drawing of the loop is depicted in Figure 1 [1]. One photograph depicting the test loop (partly) is given in Figure 2.

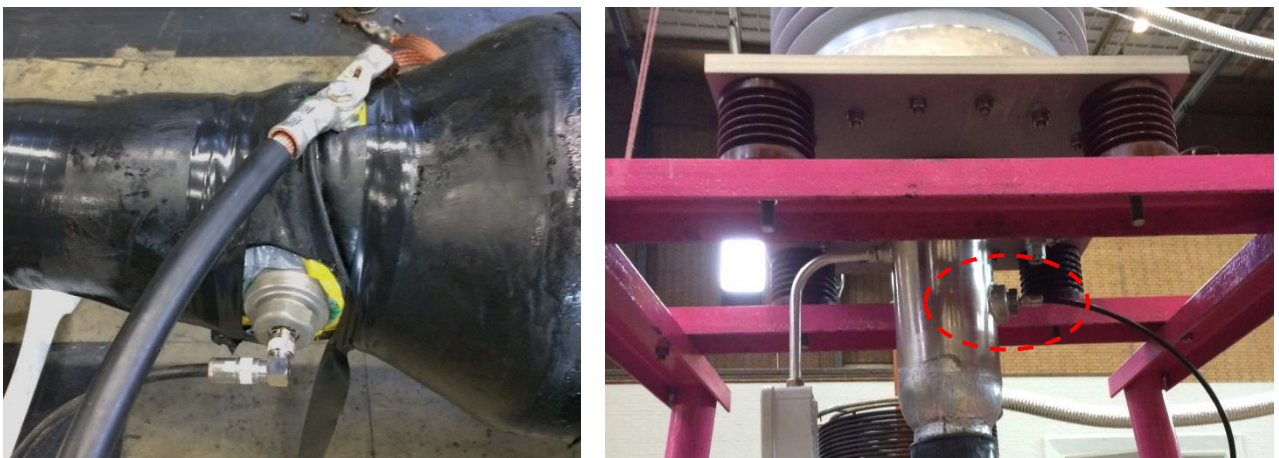
Figure 4 The HFPD sensor as mounted close to joint D (location S_3 , photo left) and close to termination A (location S_1 , photo right).

Some examples of the sensors and how these are mounted on the accessories are depicted in Figure 3 and Figure 4.

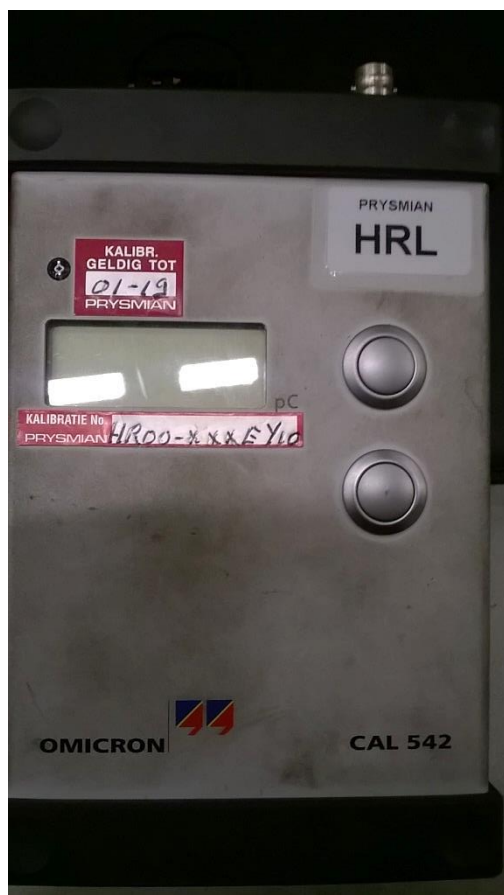
Figure 5 The PD-calibrator that was used for the tests.

Injection of calibration pulses is done using an Omicron PD calibrator type CAL542, see Figure 5. This calibrator injects pulses with a rise-time less than 4 ns and is as such suitable for the high-frequency tests that are performed.

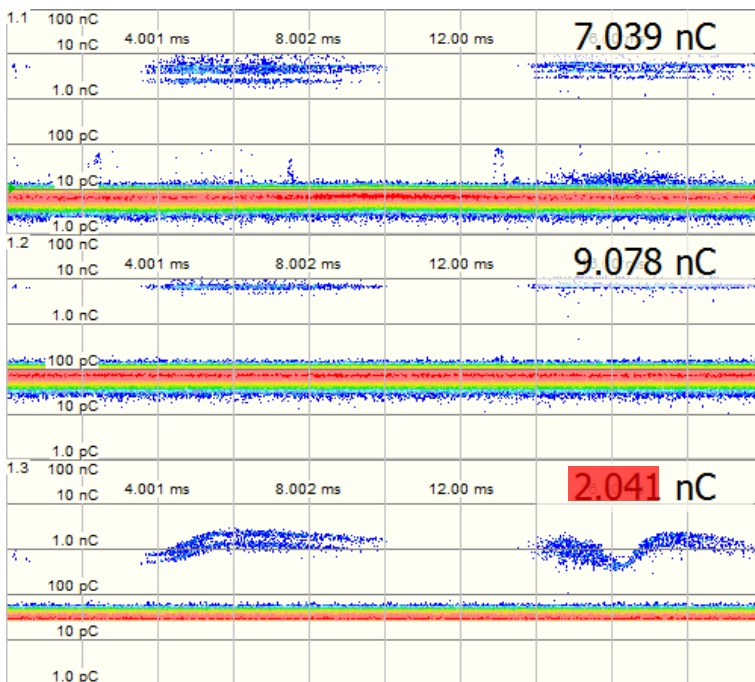
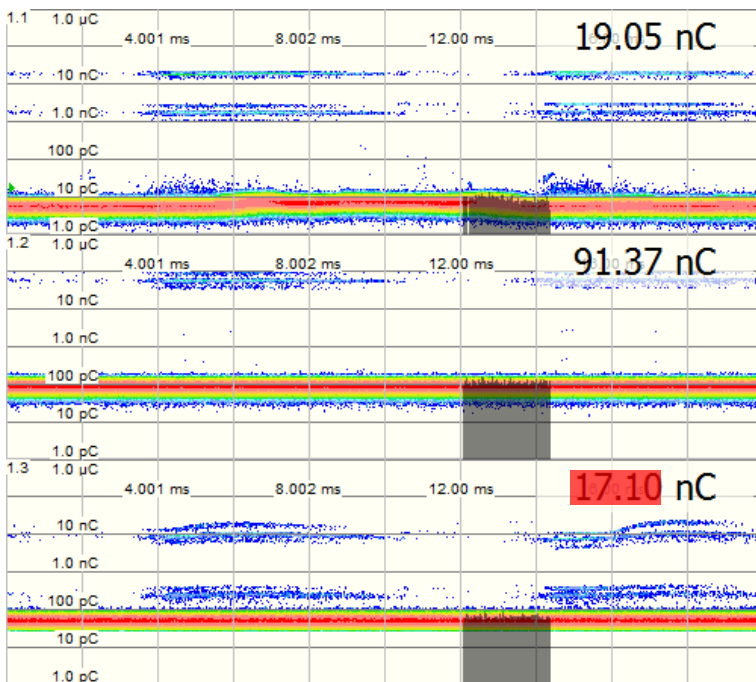
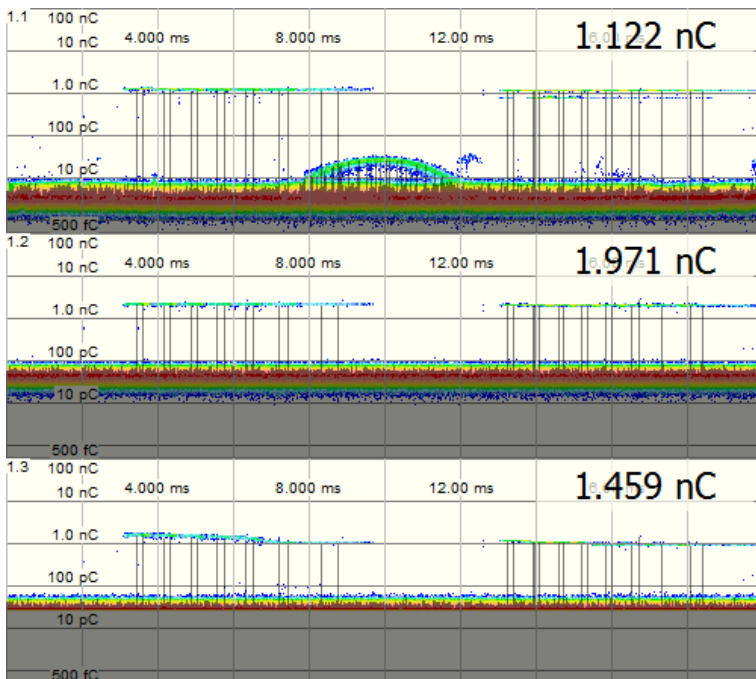
Figure 13 Results for the corona measurements at center frequency 4 MHz. From top to bottom channel 1, channel 2 and channel 3 (not calibrated, indicated by the red box).

Figure 14 Results for the corona measurements at center frequency 6 MHz. From top to bottom channel 1, channel 2 and channel 3 (not calibrated, indicated by the red box).

Figure 15 Results for the corona measurements at center frequency 8 MHz. From top to bottom channel 1, channel 2 and channel 3.

Figure 16 Results for the corona measurements at center frequency 10 MHz. From top to bottom channel 1, channel 2 and channel 3.

Figure 17 Results for the corona measurements at center frequency 15 MHz. From top to bottom channel 1, channel 2 and channel 3.

Figure 18 Results for the corona measurements at center frequency 20 MHz. From top to bottom channel 1, channel 2 and channel 3.

The results are depicted graphically in Figure 13 up to and including Figure 18. The measurement channels are connected as follows:

A significant amount of signal is picked up by the “floating” Pry-Cam Wing sensor. The dependency of the acquired signal level and the distance between the floating sensor and the ground was found again. It is quite likely that the explanation for this phenomenon is the same as for calibration procedure described in section 4.1.

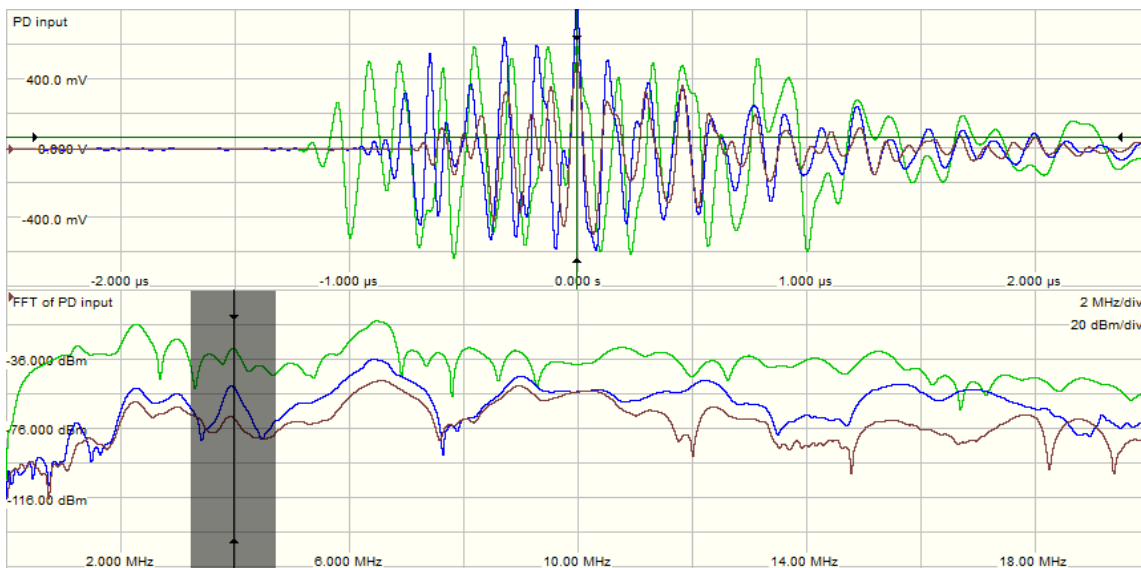
Figure 19 Example of a received corona discharge pulse for channel 1 (green), channel 2 (blue) and channel 3 (brown). The top graph shows the signal in time domain, the graph below indicated the associated frequency spectra.

The pulse shapes of the measured signals from the Pry-Cam Wing and HFPD sensors are compared, as depicted in Figure 9 for a center frequency of 4 MHz. Comparison of the waveforms is difficult, mainly due to the following practical limitations:

- The measurements are performed at a relatively small bandwidth of 1.5 MHz. Because of this, significant amounts of ringing are seen around the measured pulse (signal with a large bandwidth)
- Due to the relatively short length of the test object there are many reflections observed in the signal.

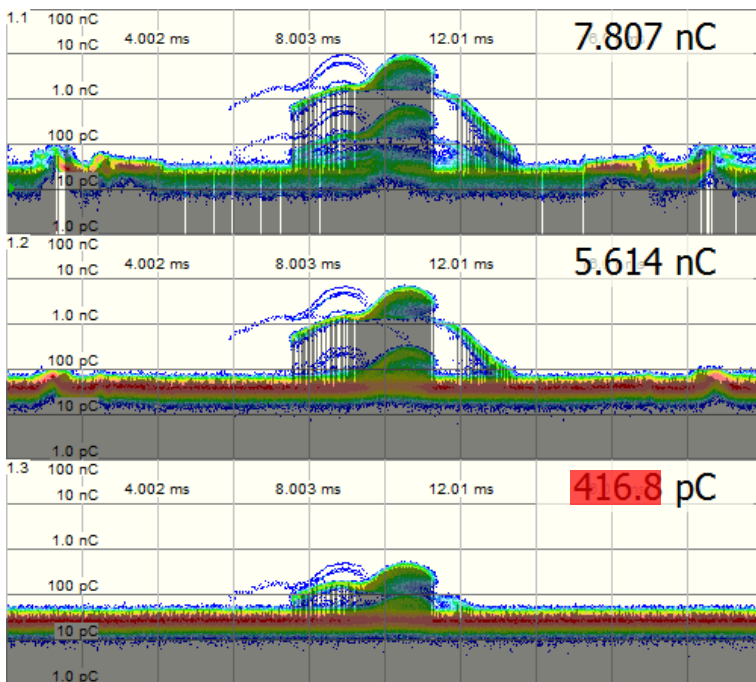
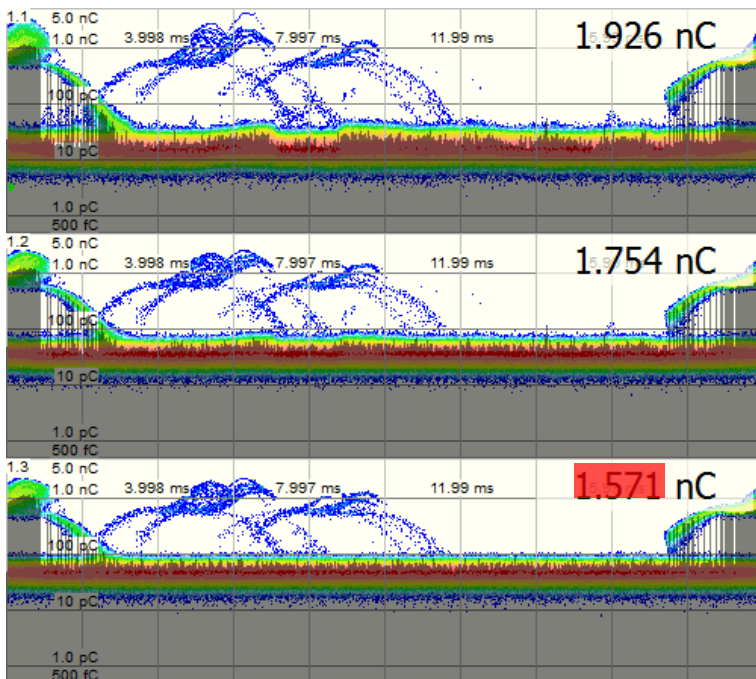
Figure 20 Results for the corona measurement at a center frequency of 2 MHz. From top to bottom channel 1, channel 2 and channel 3 (not calibrated, indicated by the red box).

Figure 21 Results for the corona measurement at a center frequency of 4 MHz. From top to bottom channel 1, channel 2 and channel 3 (not calibrated, indicated by the red box).

Figure 22 Results for the corona measurement at a center frequency of 6 MHz. From top to bottom channel 1, channel 2 and channel 3 (not calibrated, indicated by the red box).

Figure 23 Results for the corona measurement at a center frequency of 8 MHz. From top to bottom channel 1, channel 2 and channel 3 (not calibrated, indicated by the red box).

The results are depicted graphically in Figure 20 up to and including Figure 23. The measurement channels are connected as follows:
